ZEB-REVO Handles Hazardous Surveys

Britannia Bridge is the sole rail link for passengers travelling between Anglesey and mainland UK across the Menai Strait. Stuart Cadge from GeoSLAM recounts a unique survey of the bridge structure.

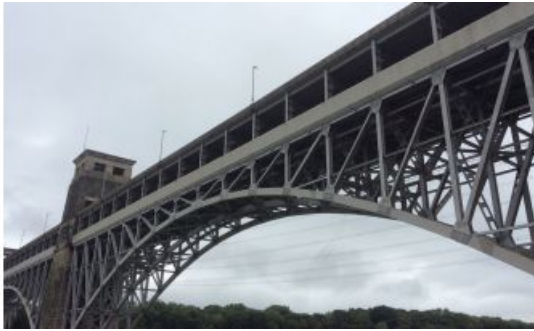
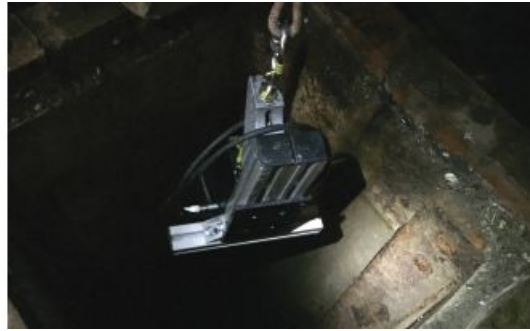
With the methodology confirmed, the lowering device was built to securely combine the ZEB-REVO scanner head and datalogger together. The scanner head was targeted in the direction of travel towards the bottom of each pier. A rope was then threaded through the eyelet at the top of the lowering device and securely attached to a tripod positioned above the narrow access hatch.

Once the equipment was positioned, the ZEB-REVO was initialised at the manhole opening of each pier. During start up, the device needs to be kept completely still in order for the inertial measurement unit (IMU) to ascertain its position. The tool was then gradually lowered down into each pier to scan the entire internal structure. Through existing bridge drawings, the Amey team knew the approximate depth of each internal column, and with an indoor range of 30m – depth was no issue.

With an average accuracy level of +/- 15mm, the challenge of such a narrow structure did not limit the ZEB-REVO's effectiveness. The 3D scans allowed Amey to undertake a more comprehensive evaluation of the physical internal 'health' of the piers. They were also able to assess what debris had sunk or drifted to the bottom of the voids – particularly crucial given the twelve-year gap between each assessment.

Ultimately, the inspection indicated that both piers are currently in good order, with minimal movement detected. However, the examination reports also helped plan for the future of the bridge, contributing to Amey's wider assessment of Britannia Bridge's structural integrity and understanding the maintenance needs required on a short and long-term basis.
